SURGICAL TOOTH IMPLANTS, COMBAT AND FIELD

Annual Report

July 15, 1982

Battelle Columbus Laboratories
505 King Avenue
Columbus, Ohio 43201

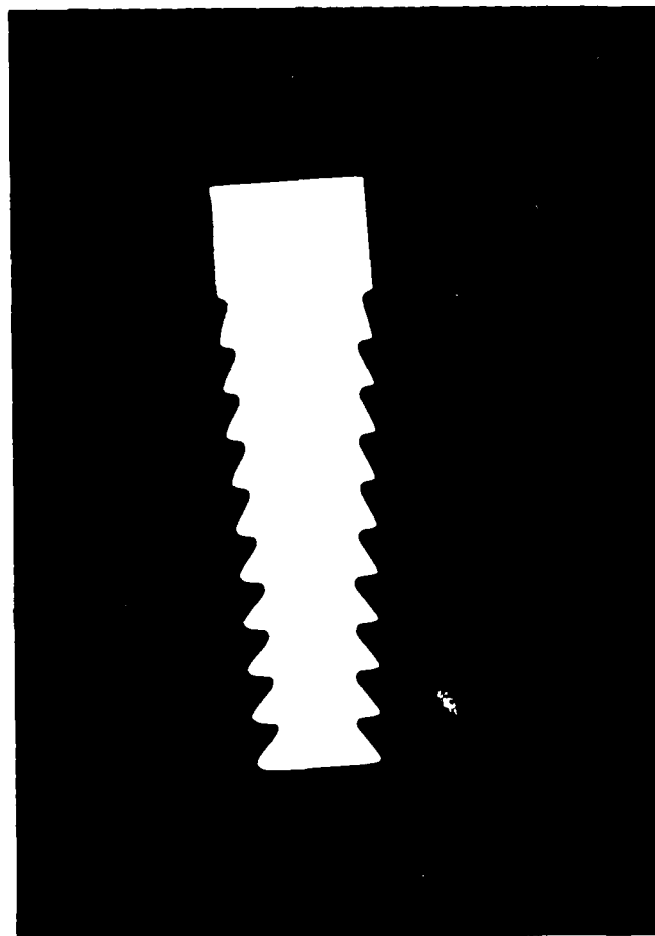
FIGURE 1. SERRATED ALUMINUM OXIDE DENTAL IMPLANT

This photograph shows a rectangular root with smaller serrations at the top for increased strength. Not visible is the post hole in the center of the implant. A prefabricated post and core is cemented into the hole. A clinical crown is then cemented to the post and core.

The lower portion of our three-piece implants are produced from alumina (Al_2O_3) (Figure 1). This portion has large serrations into which bone ingrowth has been demonstrated.⁽⁴⁾ The implant illustrated in Figure 1 has smaller serrations at the crown end of the root to increase the strength of smaller sized roots in these critical areas. The upper two portions of the implant: post and core and crown - are cemented after ingrowth to allow function. The three-piece design allows minimization of occlusal stresses and strains on the implant to facilitate bone ingrowth. An analogous situation is seen in the healing of long bone. It is assumed that, as in long bone, an orderly transition through a sequence of gradually stiffer bone materials proceeds (hematoma → connective tissue → woven bone → compact bone). The maximal strain which any of these tissues can withstand must not be exceeded if healing is to proceed to completion.⁽²¹⁾ Consequently, strain upon the implant-bone interface must be minimized early in the healing process if bone formation is to occur. Once the implant is stabilized by ingrowth, the large implant surface area at right angles to the principal load axis of the implant

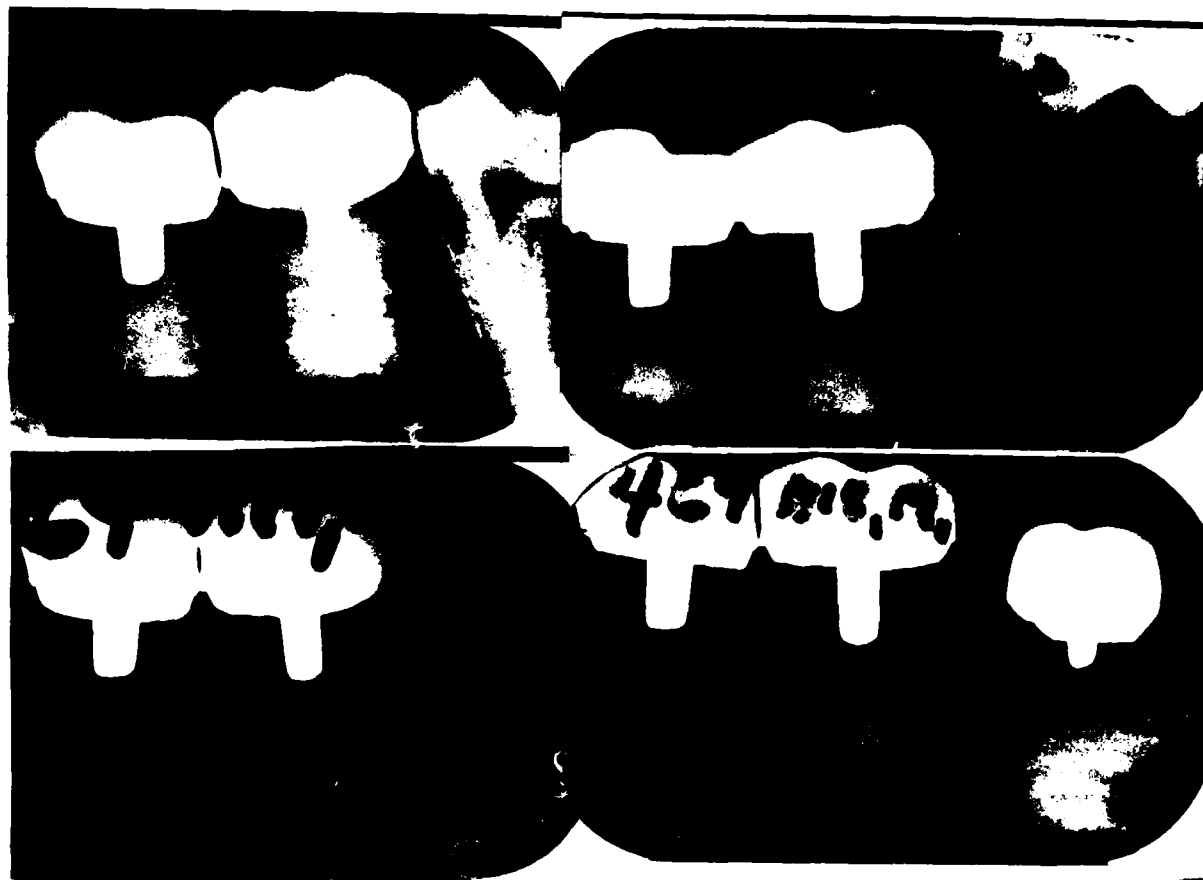
FIGURE 5. RADIOGRAPHIC HISTORY OF A18, A19, AND A20 IN BABOON 469

These radiographs, from upper left to lower right are dated: 3/2/76, 3/30/77, 11/5/79 and 3/17/82. The last radiograph is the same date as the clinical photograph in Figure 4. By the time of the first radiograph, bone is dense around the implants. The following radiographs show the events following extraction and implantation of a third root. These events precipitated a loss of alveolar bone, but the implants all remain stable despite this bone loss. Difficulties with filling a crown, and multiple procedures performed to properly fit a crown on A18 might be responsible for the large vertical bone loss around that particular implant.

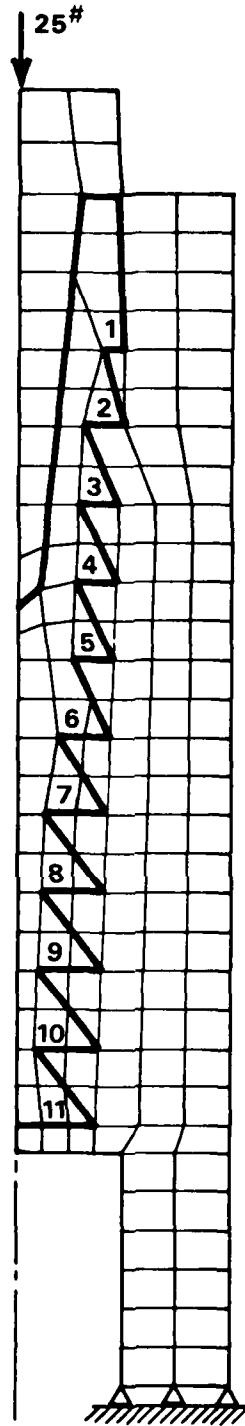
FIGURE 15. GRID REPRESENTATION OF AXISYMMETRIC MODEL OF 4 X 4 MM IMPLANT

In this figure, only one-half of the implant system is shown. The heavy line shows the outline of the ceramic implant.

Figure 15 is the grid representation of the mathematical model. For simplicity, only one-half of the implant is shown in cross section. The relatively thin cortical plates of bone and the thin layer of bone below the implant are characteristics normally noted histologically. The outline of the implant indicates the area which is ceramic. The post area and the portion above the top of the implant is gold. The remaining area is bone.

The following elastic moduli were used in the model: ceramic, 54.53×10^6 psi; gold, 11.92×10^6 psi; and bone, 1.98×10^6 psi. Using these constraints, the data shown in Table 3 were computed for an axial (occlusal) static load of 25 pounds. These calculations are for the smallest implant (4 mm x 4 mm). This size implant would have the highest stresses under the serrations because it has the smallest surface area of serrations to
